GAO

January 1993

FINANCIAL
MANAGEMENT

Poor Internal Control
Has Led to Increased
Maintenance Costs and
Deterioration of
Equipment

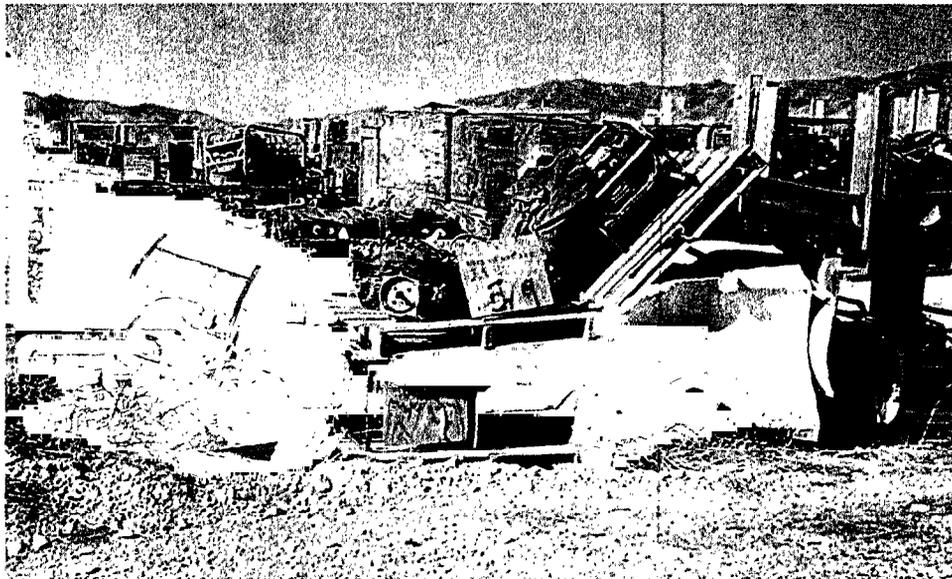
each other in a totally disorganized manner, as shown in figure 3.1. No space was provided between many of the pallets on which the generators were stored, many of the pallets were unstable, and many generators were barely visible, making it difficult to distinguish the different types. Depot officials acknowledged that prior counts of these generators had resulted in mixed stock/classification problems because staff could not get close enough to the items to make an accurate count.

Figure 3.1: Unprotected Outdoor Storage and Improper Stacking of 1.5 Kw Generator at Tooele Army Depot

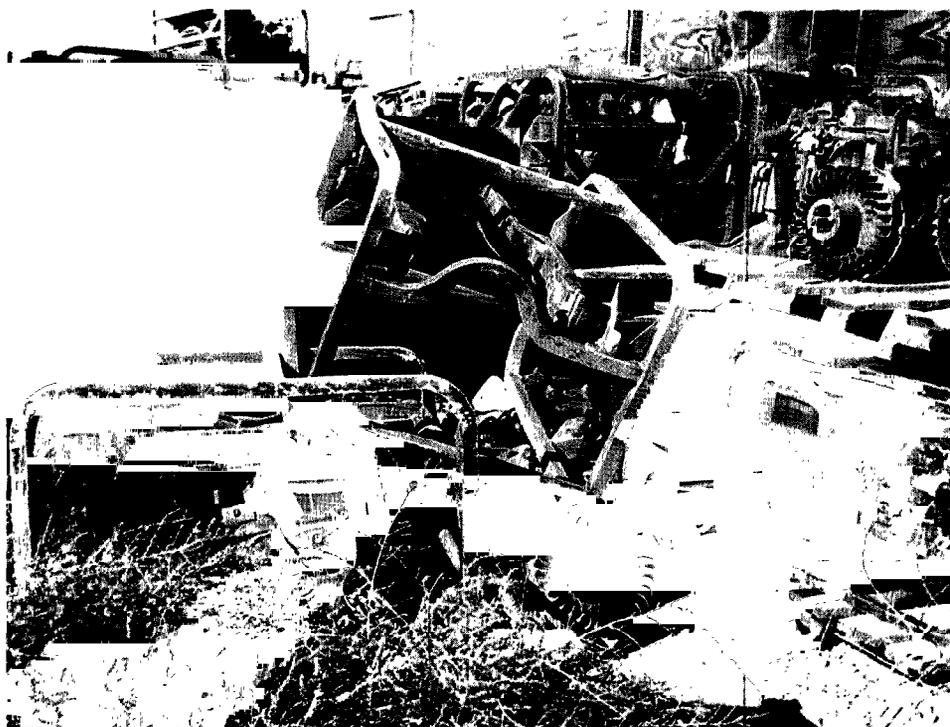
Frames on these 1.5 KW generators were damaged due to improper stacking at Tooele Army Depot.
