**Report to the Chairman, Subcommittee
on Readiness, Committee on Armed
Services, House of Representatives**

July 1994

NAVY SUPPLY

**Improved Material
Management Can
Reduce Shipyard Costs**

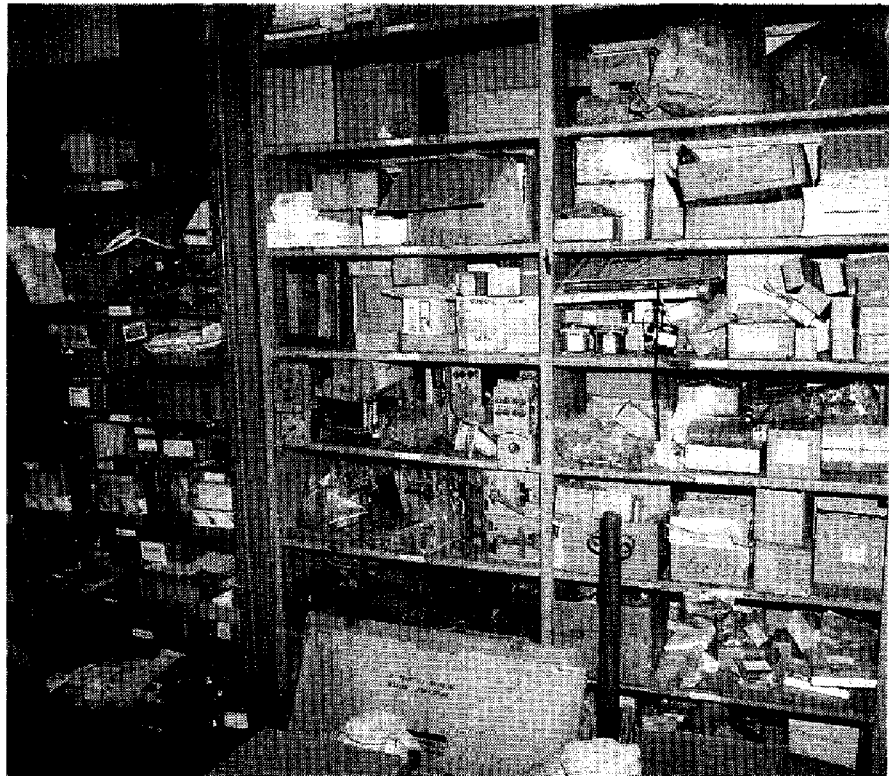
In the electronics shop's communications work center, the supervisor did not keep a list of goldpile material. However, we observed about 15 large cabinets containing goldpile material. In about 20 minutes we recorded the stock numbers for 28 items and counted the on-hand quantities. The cost of this material was over \$29,000.

Figure 3.1: Unrecorded Material in Norfolk's Fire Control Work Center

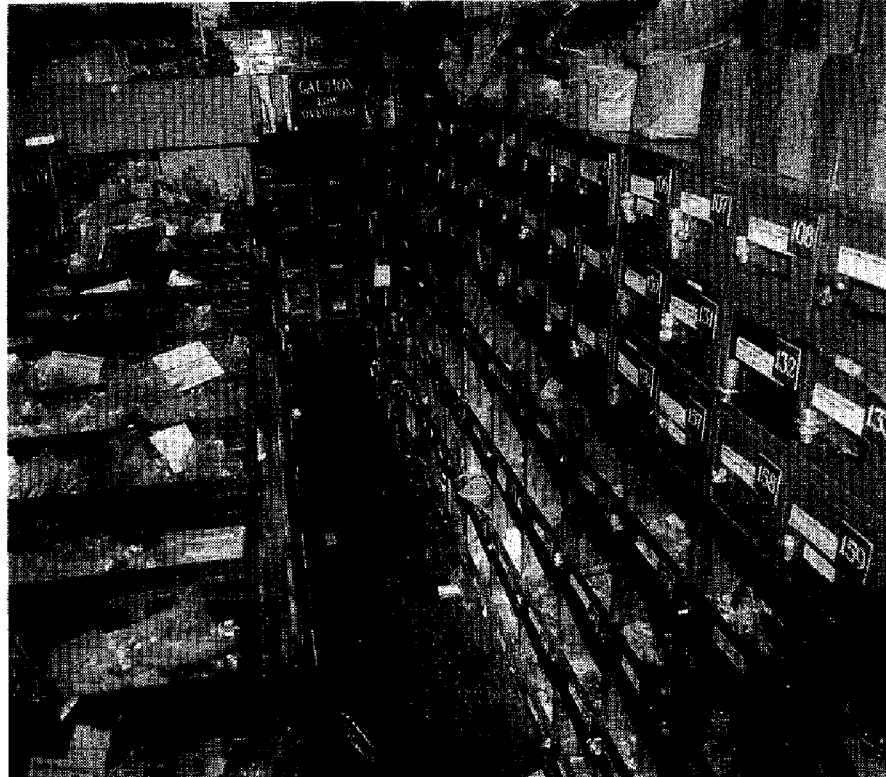
Figure 3.2: Unrecorded Material in
Norfolk's Plug Work Center
