GAO

Testimony

Quality and Safety Problems With the
Beretta M9 Handgun

Statement of
Milton J. Socolar,
Special Assistant to the Comptroller General
Office of the Comptroller General

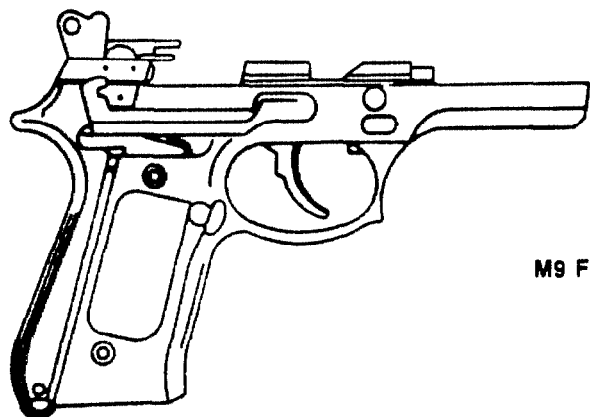
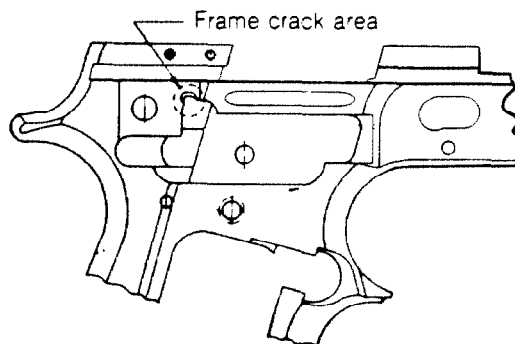
M9 Frame, Overall View

The Beretta M9 has also experienced frame cracks, and as a result, the Army rejected the December 1987 and January 1988

production lots totaling about 12,000 weapons. The figure below illustrates where the cracks occurred.

According to Army officials, the frame cracks were cosmetic in nature and did not affect the M9's safety or reliability. Nevertheless, the contractual acceptance testing process does not allow for any cracked or broken frames.

Indications of frame cracks were first noticed during lot production testing of M9s manufactured in September and October 1987. At that time, the Defense Contract Administration Services representative at the Beretta plant recommended that the Army not accept the two lots totaling about 12,000 handguns. However, the M9 program office overruled the recommendation because there was no clear evidence that the frames were cracked.

Production lot testing of the November 1987 lot did not indicate any frame cracks. However, during December 1987 and January 1988 lot testing, frame crack indications reappeared. Based on these tests, the Army rejected the two production lots.

An engineering change proposal (ECP) to modify the manufacturing process to correct the frame crack problem was implemented by Beretta in April 1988. As of August 17, 1988, the

12,000 M9s handguns manufactured during December 1987 and January 1988 as well as those manufactured in February and March 1988 have been reworked, tested, and accepted by the Army. The 6,000 M9s manufactured in April 1988 were submitted to the government for acceptance in late August. A total of 591 of these weapons were manufactured before the ECP was implemented.

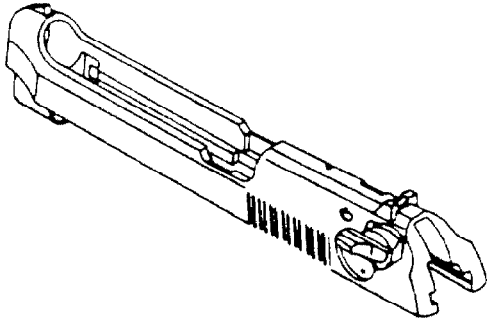
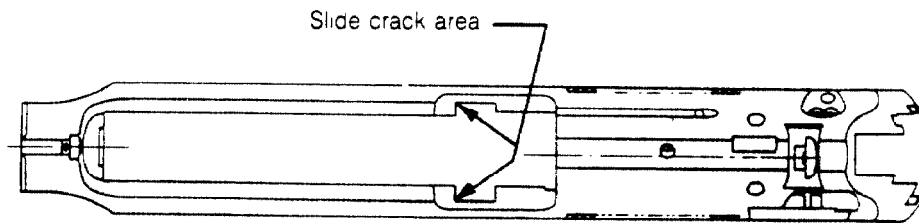
M9 Slide, Overall View

The M9 has experienced several slide failures. The Army has determined that a fatigue crack located near the slide's locking lug slot can cause a catastrophic break in the slide when it reaches the full aft firing position. (See figure below.)

The Army has not determined what causes the metal fatigue. To date 14 failures have been reported: three involving Navy-owned handguns and 11 involving Army-owned handguns. The three Navy failures occurred under operational conditions, and the other 11 failures occurred during laboratory testing.

What is of particular concern is the safety hazard encountered when failure does occur. The slide breaks into two parts and the rear part flies back at the shooter. Injuries resulting from four slide failures included face lacerations requiring stitches, a broken tooth, and a chest bruise. After the first three slide failures, all laboratory testing of the M9 was conducted with the shooter behind a protective shield.

While Army analysis of the failed slides has determined that metal fatigue is the primary cause of failure, exactly why this occurs still puzzles the Army.

The Army's current focus is on ensuring that if a slide fails, the broken pieces will not fly back and injure the shooter. The Army is also pursuing ways to eliminate the cause of the metal fatigue that causes the slide to break. We were told by the program office that the Army plans to stop accepting delivery of M9s, after the April 1988 lot is tested, until the slide problem is resolved. They estimate that acceptance of M9s could resume sometime in January 1989.

number of rounds fired and to replace the slides about every 3,000 rounds.
