Report to the Honorable Tom Harkin, U.S. Senate

October 1999

DEFENSE ACQUISITIONS

Army Purchased Truck Trailers That Cannot Be Used as Planned

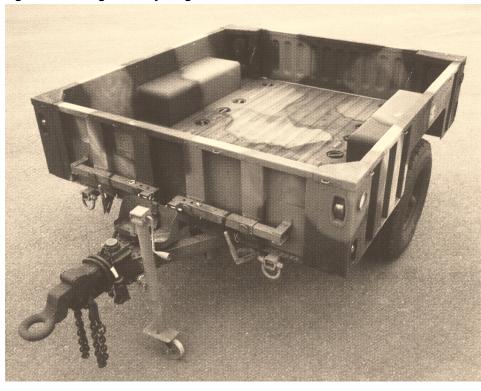
The new trailer (see fig. 1) was designed to be compatible with both the light and heavy High Mobility Multipurpose Wheeled Vehicles. Differences in the two trucks required that two cargo versions of the trailers be produced. The light cargo trailer was to carry at least 1,500 pounds and the heavy cargo trailer was to carry at least 2,500 pounds. The new trailers also included a chassis version that was to carry at least 2,700 pounds. The Army required the trailers to have the same track width and tires as the truck and inertia brakes, called surge brakes, which are actuated by forces between the tow hitch of the truck and the drawbar of the trailer. The trailer was to be capable of being towed at speeds up to 20 miles per hour cross-country, 35 miles per hour on secondary roads, and 55 miles per hour on primary roads.

Figure 1: The High Mobility Cargo Trailer
